ANNUAL UPDATE

FOR AUGUST 1, 1997 THROUGH
AUGUST 1, 1998

HISTORICAL RELEASE REPORT (HRR)

RF/RMRS-98-269.UN
REVISION 0

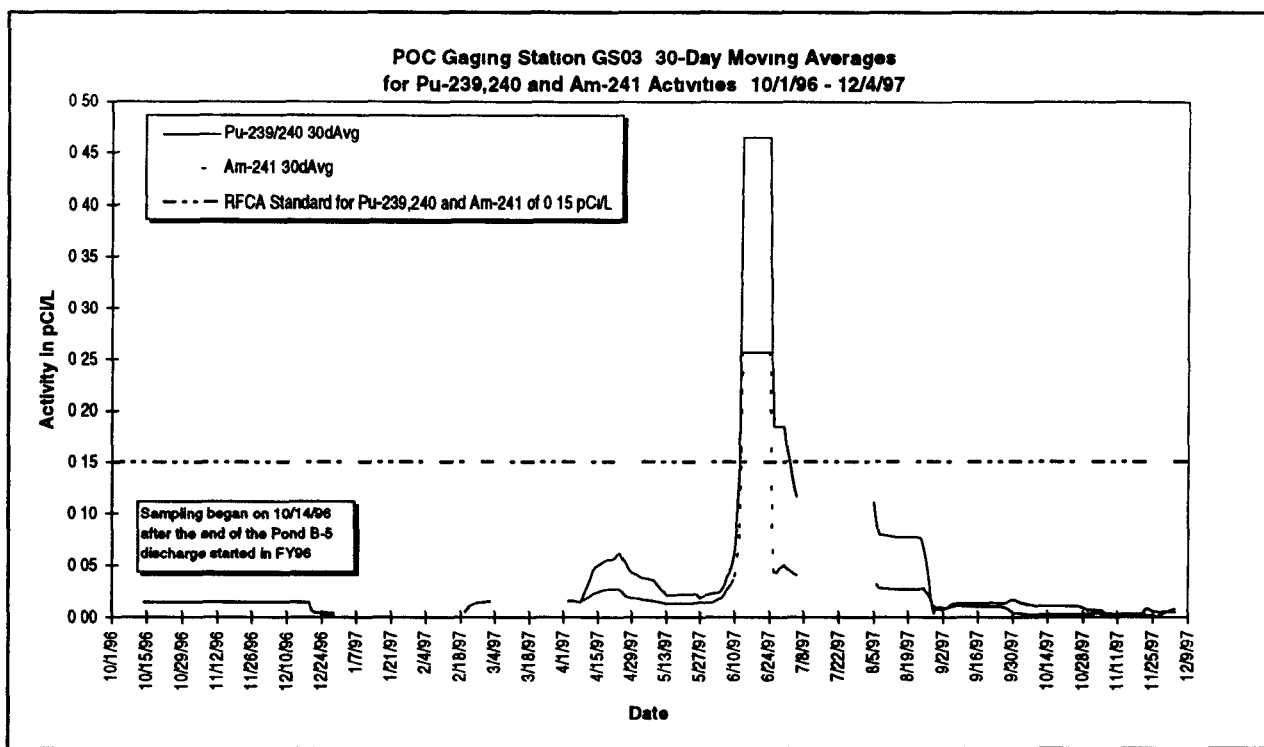
Figure 4-1(a). POC Gaging Station GS03 30-Day Moving Averages

- RFCA-reportable 30-day moving average values were measured at the POC monitoring location at Walnut Creek and Indiana Street (referred to as GS03) for the period June 12 through July 2, 1997 (see Figure 4-1(a) and Table1),
- RFCA-reportable 30-day moving average values were also measured at the POE monitoring location above Pond B-1 (referred to as GS10) for the periods April 13 through April 24, 1997, May 25 through June 20, 1997, August 2 through October 21, 1997 (DOE, 1998b), and
- RFCA-reportable values were observed at the POE monitoring location above Pond A-1 (referred to as SW093) for the period August 2, 1997 through August 3, 1997

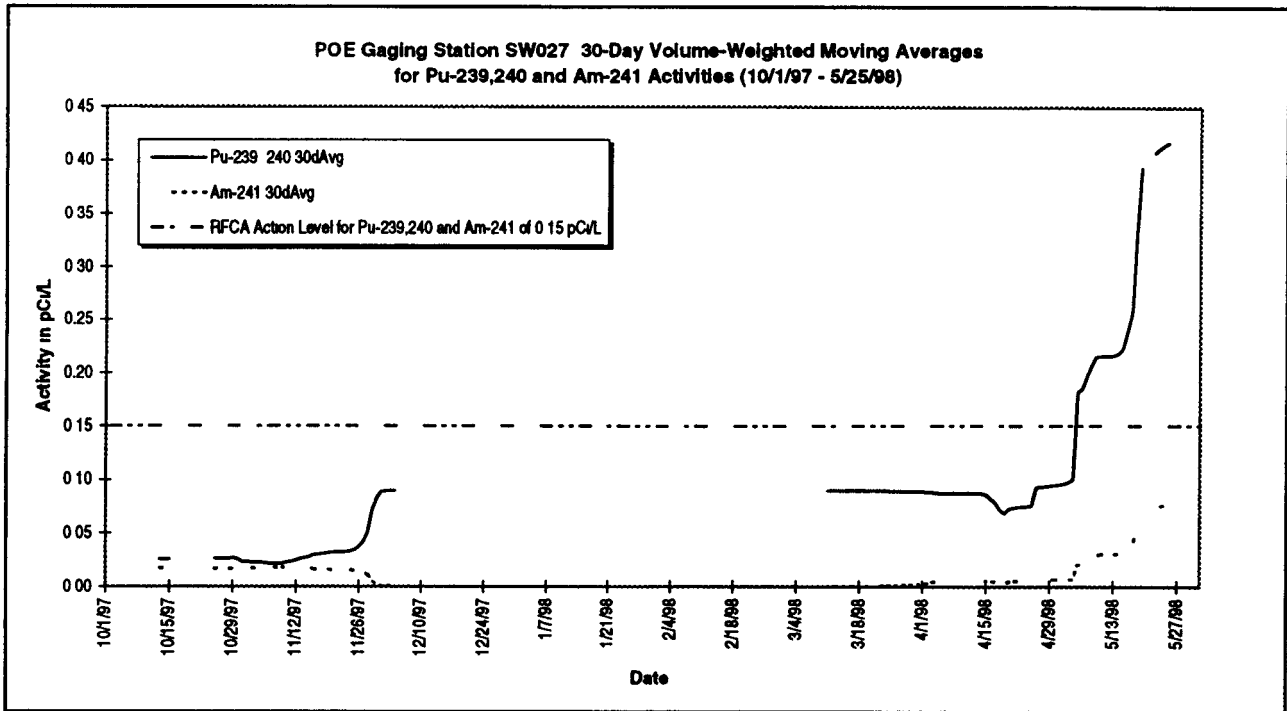
Figure 4-2. Gaging Station SW027 30-Day Averages WY98 to Date

The laboratory narrative for the individual analytical results for the composite samples collected around the period of these reported 30-day averages has been reviewed and there is no reason to question the accuracy of these results. A review of historical monitoring data shows that these results are not unusual. Storm-event and grab samples collected at SW027 from 1990 through 1996 (under pre-RFCA protocols) had an arithmetic average plutonium-239/240 activity of 0.25 pCi/L with a maximum of 2.29 pCi/L. The apparent trend upward during Water Year (WY) 98 is likely due to seasonally increasing flow rates and precipitation intensity which result in increased transport of suspended material. Individual composite sample results and details are shown in Table 2 for the period of interest.

Note Gaps in the 30-day average above are for periods of zero flow at SW027
